F-4 Tornado

By Hank Petit and Robert W. Chambers

This July a powerful tornado hit a log home that Hank Petit built in northern Wisconsin. There was surprisingly little damage to the log walls and log roof system.

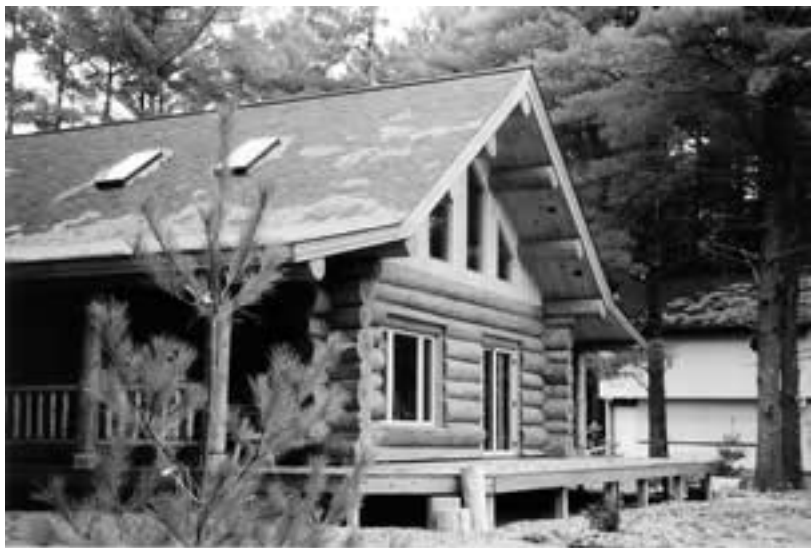
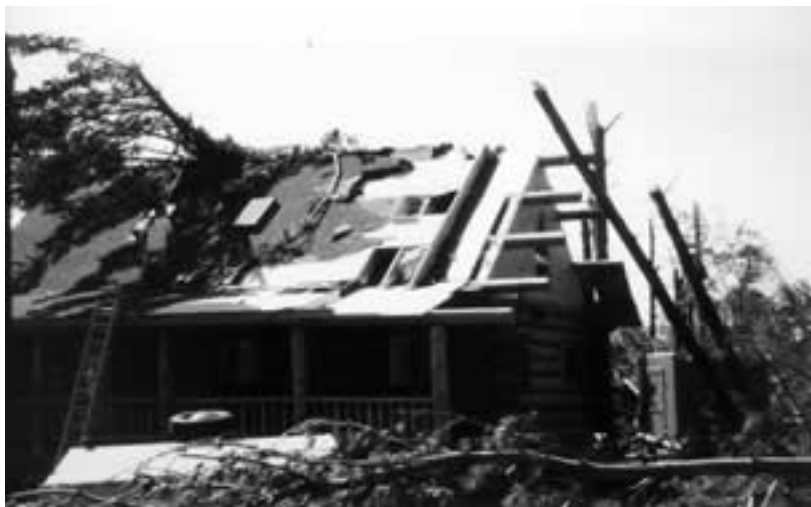
The house sustained damage as follows. The roof sheathing was stripped off the rafters, and many rafters were stripped from the purlins, with the worst damage on the gable end that was hit first by the tornado. Ceiling boards (3/4" T&G car siding) was stripped off the 4-foot gable overhang. Windows and skylights were broken.

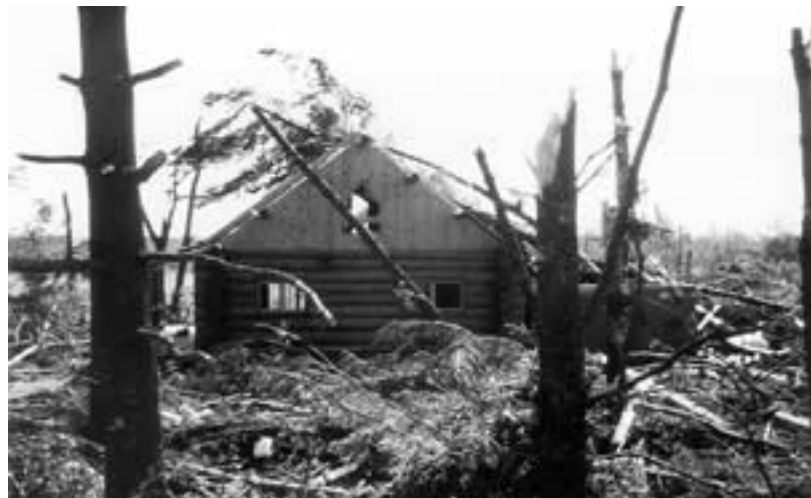
At door and window openings, the logs had been twisted clockwise (viewed from the top), and the openings the logs stepped out 1/8" to 1/4" per round. Every layer of logs moved, right down to the bottom sill logs. Door openings had about 2" out of plumb from top to bottom.

But the log walls from the door headers up to the plate logs seemed to have moved as a unit—these 3 rounds of logs had not noticeably slid along one another.

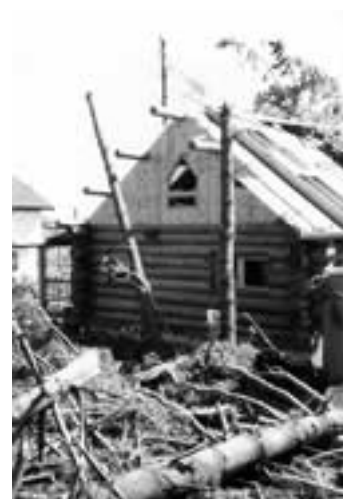
When the headers were pulled, even the islands of wood between a door and window followed with it.

Finally, just two of the openings had to be re-cut—their logs had not lined up again.

To straighten the building (rotated it back counterclockwise), Hank hired a semi-truck wrecker with a 40-ton winch, and parked it in a place where the winch cable could be fed in through a door opening, and around the top 3 rounds of logs. Tension was put on the winch, which was not enough to pull the building around by itself. But when the log walls were tapped with a backhoe bucket on the other wide, the jiggling, followed by some creaking brought the building right. Two days were spent, mostly rigging for the pull and removing both porch roofs on the eave sides (to give access to winching and tapping).
